Upgrade to Prim

SOFTWARE CHANGES

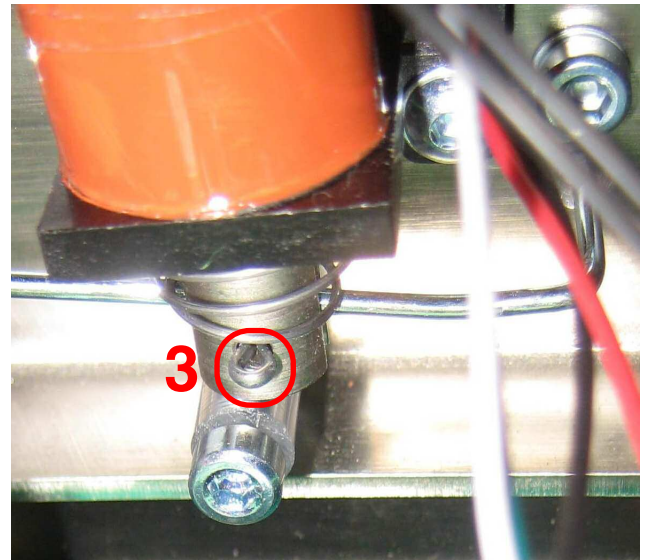
We recommend that you study how the solenoid's spring sits before you dismantle it. Note how the closed end of the spring (3) is mounted with its closed end visible.

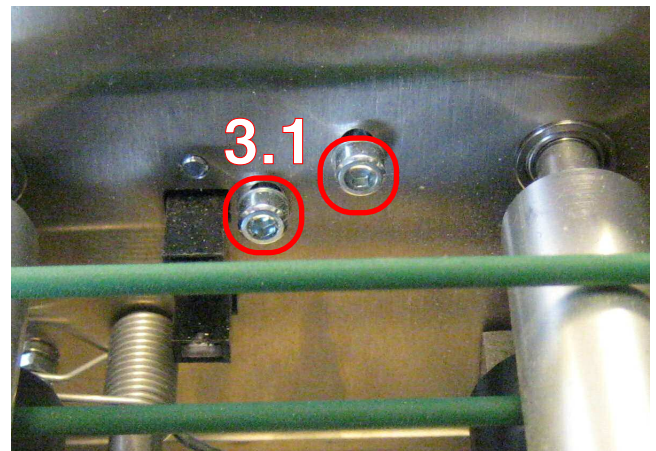
3.1 Release the solenoid

The solenoid is released from the card path by unscrewing two bolts (3.1).

4.3 Lock the bolts (3.1) firmly and repeat the process on the two other gates.

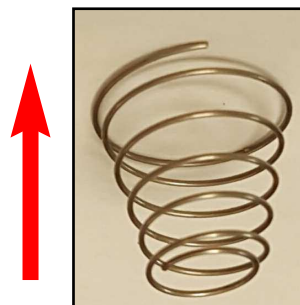
3.2 Replace the spring

Replace the old spring with the new, stronger one (with a thicker metal thread).

Note that the spring's larger diameter end shall be up while the smaller diameter shall rest on the gate.

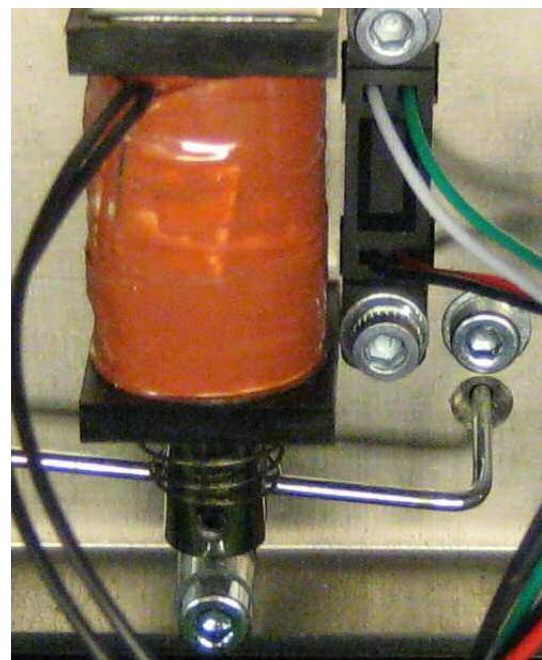
4. ADJUST THE HEIGHT

You should keep an eye on the solenoid while adjusting the gate's height. The solenoid shall be "just past 12" as shown below.

4.2 Next check that the distance between the closed gate and the edge of the card is > 3 mm.
